**OFFICE OF DEFECTS INVESTIGATION
CALSPAN ON-SITE AIR BAG NON-DEPLOYMENT FATAL CRASH INVESTIGATION
SCI CASE NO: CA09022**

**VEHICLE: 2005 CHEVROLET COBALT
LOCATION: PENNSYLVANIA
CRASH DATE: APRIL, 2009**

1. Report No. CA09022		2. Government Accession No.		3. Recipient's Catalog No.	
4. Title and Subtitle Calspan On-Site Air Bag Non-Deployment Crash Investigation Vehicle: 2005 Chevrolet Cobalt Location: Pennsylvania				5. Report Date: February 2010

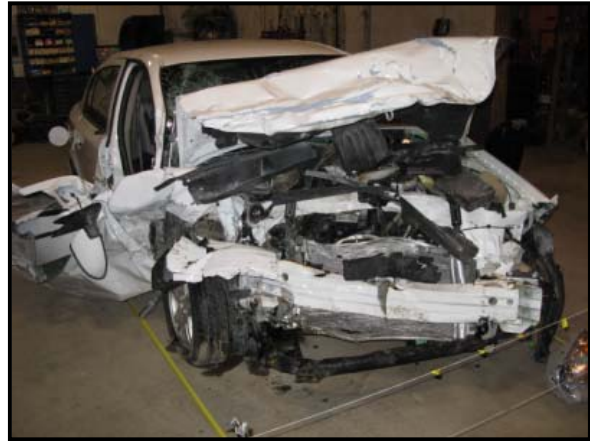
This on-site investigation focused on the fatal air bag non-deployment crash of a 2005 Chevrolet Cobalt (**Figure 1**). The Chevrolet was involved in a severe head-on collision with a 2001 Hyundai Sonata that resulted in three fatalities. The 2005 Chevrolet Cobalt was equipped with dual-stage air bags for the driver and front right passenger positions that did not deploy in the crash. The vehicle's Event Data Recorder (EDR) was imaged during the SCI investigation and a non-deployment event was recovered. The driver air bag in the Hyundai Sonata deployed during the impact. The 73-year old unrestrained driver and the 13-year old unrestrained front right passenger of the Chevrolet and the 47-year old unrestrained driver of the Hyundai were all pronounced deceased at the crash site. A 12-month-old male was restrained in a forward facing convertible Child Restraint System (CRS) in the center rear position of the Cobalt. The child sustained a critical cervical spine injury and was transported from the crash site to a pediatric trauma center via air ambulance.

Figure 1: Front right oblique view of the Chevrolet.

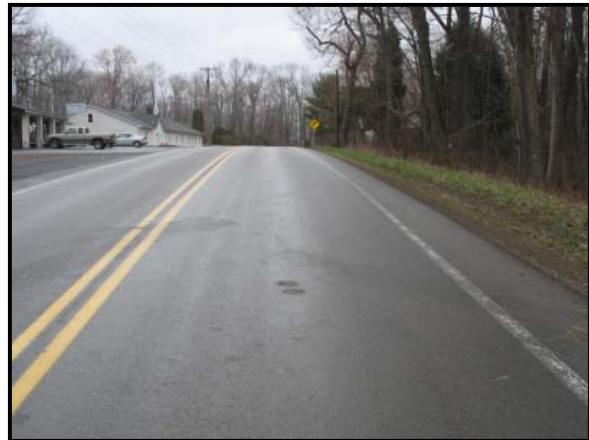
Figure 2: Eastbound trajectory view at the point of impact.

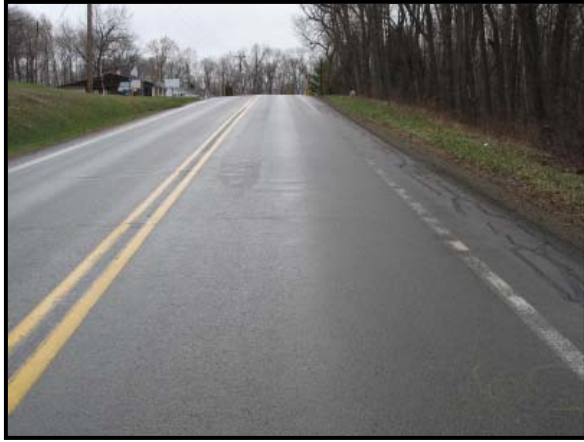
Figure 3: Eastbound approach view 90 m (300 ft) from the point of impact.

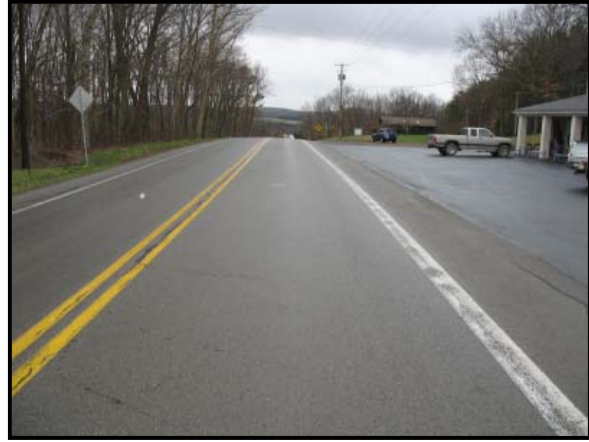
Figure 4: Westbound approach view 60 m (200 ft) from the point of impact.

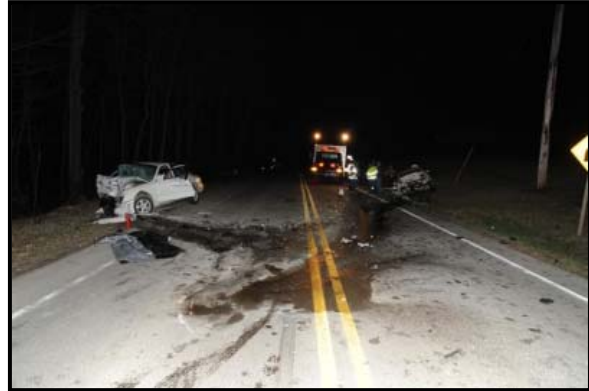
Figure 5: On-scene police image of the crash site.

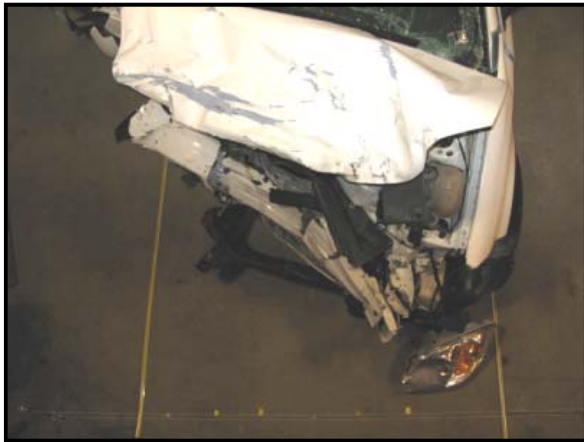
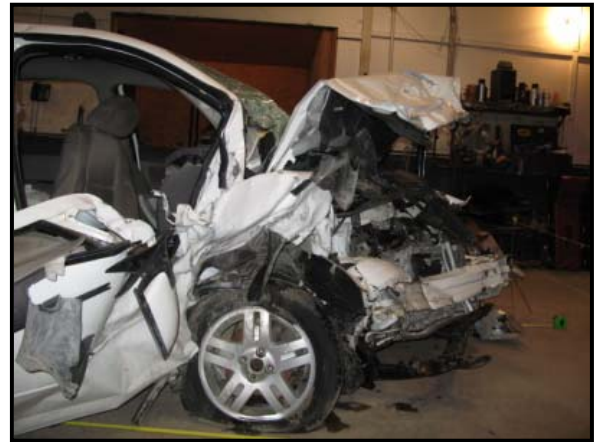
The 2005 Chevrolet Cobalt sustained severe damage from the off-set frontal collision with the Hyundai. **Figures 6 and 7** are an overhead and right side view of the deformation. The width of the direct contact damage measured 117 cm (46.1 in). The direct contact began 51 cm (20.1 in) left of center and extended to the right corner. The combined direct and induced damage extended across the entire 132 cm (52.0 in) end width. The damage pattern was biased to the right indicative of the offset impact configuration and the evasive left steering by the Chevrolet's driver. The damaged components included but were not limited to the front bumper fascia, bumper reinforcement beam, upper and lower radiator supports, headlight assemblies, fenders, right A-pillar, and the right front suspension components. As the vehicles crushed, the right wheel was displaced rearward into the wheelhouse and right cowl. The wheel rim fractured.

The right A-pillar was deformed rearward 40 cm (15.8 in) and the lower third of the pillar deformed to a vertical orientation. The front right door was compressed 19 cm (7.5 in) and buckled outboard. The right roof side rail was buckled to the right B-pillar location. The upper aspect of right front shock absorber tower deformed rearward 53 cm (21.0 in). The right wheelbase was reduced 41 cm (16.1 in). The left wheelbase lengthened by 8 cm (3.1 in) due to body distortion of the Cobalt. The residual crush profile documented along the bumper reinforcement was as follows: C1 = 7 cm (2.8 in), C2 = 40 cm (15.7 in), C3 = 73 cm (28.7 in), C4 = 81 cm (31.9 in), C5 = 89 cm (35.0 in), C6 = 79 cm (31.1 in). The maximum crush was 89 cm (35.0 in) at C5. The left front and right side doors were jammed closed by the impact. The left front and right front doors were opened by rescue personnel evidenced by extrication damage to the respective B-pillar areas. The right rear door compressed rearward and overlapped the quarter panel and C-pillar. The maximum overlap measured 2 cm (1 in). The windshield was fractured and the right front door glazing disintegrated during the crash. The left side, backlight, and right rear door glazing were intact. The Collision Deformation Classification (CDC) of the Cobalt was 12-FDEW5.

Figure 6: Overhead view of the Cobalt's frontal damage.

Figure 7: Right lateral view of the frontal damage.

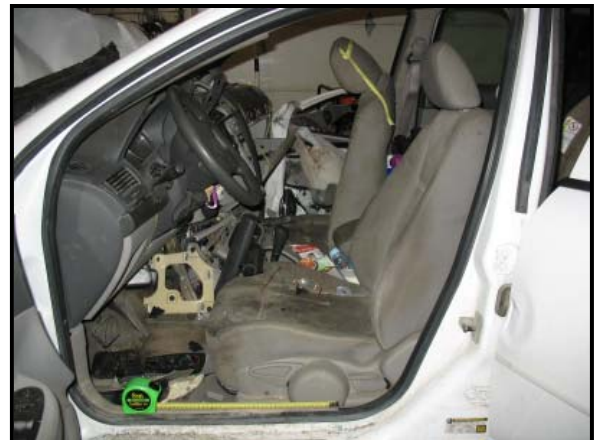
The interior of the Chevrolet sustained severe center and right frontal intrusion as a result of the exterior crash force. The unrestrained Row 1 occupants translated forward and contacted the vehicle's interior forward of their respective seat positions in response to the frontal impact force. This pattern was evidenced by multiple occupant contact points. **Figure 8** is a left lateral view of the front interior.

Figure 8: Left lateral view of the front interior.

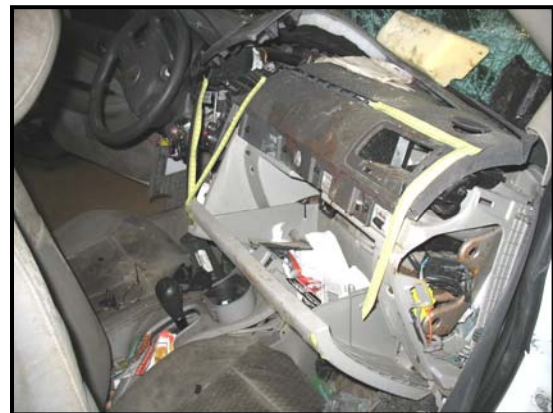
The unrestrained front right occupant responded to the frontal impact with a forward trajectory and contacted the right instrument panel with her chest. The outboard aspect of the panel was fractured. Body fluid transfers were noted over a 48 cm x 30 cm (19 in x 12 in) contact area. Refer to **Figure 9**. Her lower extremities contacted the glove box door. A 10 cm (4 in) wide head contact was identified on the inboard aspect on the right sun visor.

Figure 9: Right instrument panel contact evidence and the non-deployed passenger air bag.

The frontal air bag system in the Chevrolet Cobalt consisted of dual-stage driver and front right passenger air bags that did not deploy as a result of the crash. The cause of the non-deployment could not be determined. The driver air bag was located in the center hub of the steering wheel rim. The front right air bag module was a top-mount design located in the right aspect of the instrument panel. The vehicle was not equipped with side impact air bags. The frontal air bag system was controlled by a Sensing Diagnostic Module (SDM) that was located under the center console between the front seats. The SDM had Event Data Recorder (EDR) capabilities that could capture data at the time of a crash. The SDM was removed by the police investigator and was imaged by the SCI investigator at the time of the inspection.

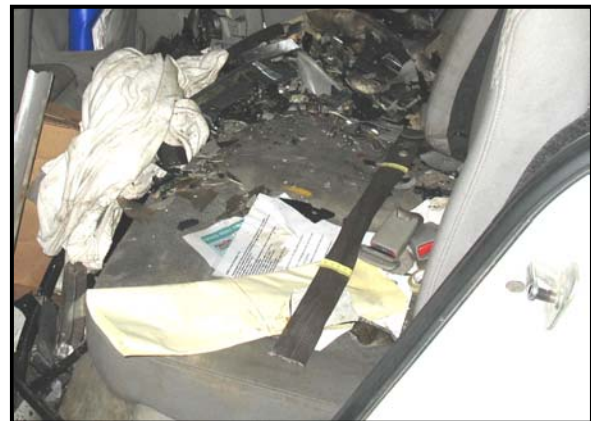
The three rear belt systems utilized switchable ELR/ALR retractors. The rear center safety belt was used to install the convertible CRS in the forward facing mode. The lap and shoulder belt webbing was routed through the forward facing belt path of the child safety seat. The webbing was cut post-crash by rescue personnel in order to remove the seat. The cut section of the belt webbing measured 77 cm (30.3 in), **Figure 10**. The balance of the webbing had spooled back into the retractor. The cut webbing contained a 45 cm (17.7 in) section that was loaded from its interaction with the belt path of the CRS. The loading began 13 cm (5.1 in) above the seat bight. The latch plate was found fastened in the center rear buckle. Extensive frictional abrasions were noted to both sides of the latch plate friction surface. These abrasions occurred as a result of the CRS loading of the webbing during the crash event. Refer to the *Child Restraint System* section of this report regarding further information regarding the use of the CRS.

Figure 10: View of the center rear safety belt.

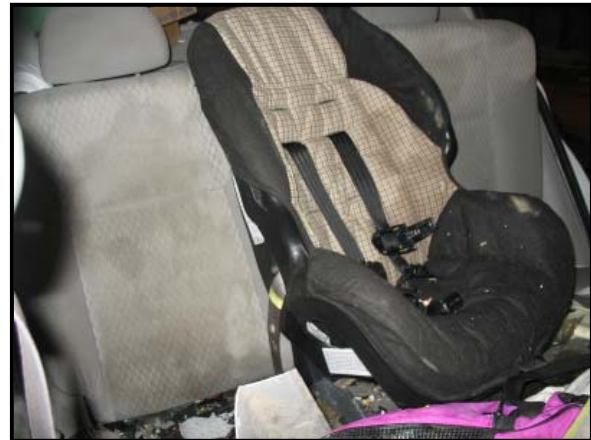
The 12-month-old male child was restrained by the five-point harness system of a Cosco Scenera S convertible CRS in the second row center position of the Cobalt, **Figure 11**. The CRS was restrained to the vehicle by the center three-point belt webbing routed through the forward facing belt path. The adjustable foot was in the extended position for forward facing use.

Figure 11: View of the Cosco CRS.

The shell was designed with four slots for adjustment of the harness straps. The straps were positioned in the second row from the top. The left strap was twisted one turn and the strap was roped in the chest retainer clip and left buckle. There was no residual evidence of loading to the harness. The chest retainer clip and buckle were operational. Examination of the upper shell was unremarkable for damage. Minor abrasions from interaction with the vehicle's safety belt were noted adjacent to the slot of the forward facing belt path.

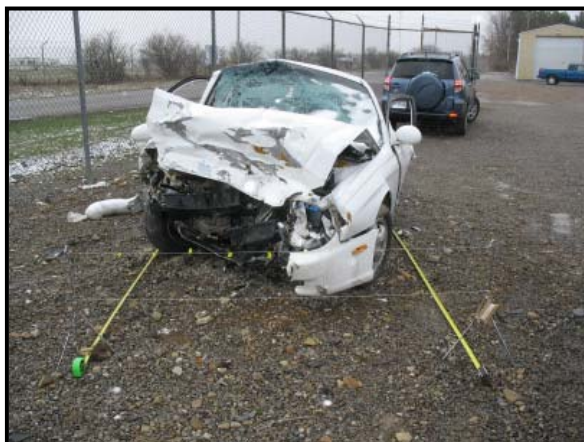
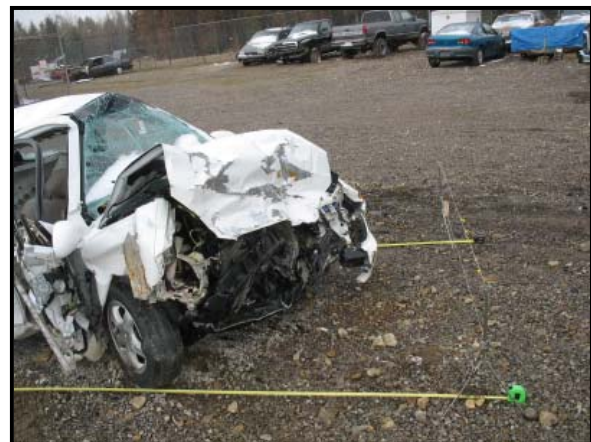
The 2001 Hyundai Sonata sustained severe frontal damage as a result of the impact with the Chevrolet (**Figures 12 and 13**). The width of the direct damage extended across the entire 147 cm (58 in) frontal end width of the Sonata. The right bias of the impact and extent of crush deformed the left front corner 23 cm (9 in) to the right. The bumper reinforcement and forward components deformed into the engine compartment. The front right wheel assembly crushed rearward into the lower A-pillar. The upper aspect of the A-pillar deformed and was near vertical. The rake angle measured 80 degrees from horizontal. The roof was buckled vertically above the front right position. The rake angle of the undeformed left upper A-pillar measured 35 degrees. The rearward displacement of the right upper shock absorber tower measured 65 cm (25.6 in). The left upper shock tower was displaced 10 cm (4.1 in). The residual frontal crush documented along the bumper reinforcement was as follows: C1 = 46 cm (18.1 in), C2 = 86 cm (33.9 in), C3 = 94 cm (37.0 in), C4 = 104 cm (40.9 in), C5 = 117 cm (46.1 in), C6 = 110 cm (43.3 in). The maximum crush was 117 cm (46.1 in) at C5. The right wheelbase was reduced 86 cm (33.8 in). The left wheelbase was reduced 12 cm (4.7 in). The front right door crushed 48 cm (19 in), bowed outboard and was jammed closed. The right rear door and the left doors remained closed during the impact. These were opened by the first responders and could not be relatched due to body deformation. The windshield was fractured. The front left and front right glazings disintegrated. The rear left, backlight and rear right glazings were intact. The CDC of the Hyundai was 12-FDEW5.

Figure 12: Front view of the Hyundai.

Figure 13: Right lateral view of the frontal deformation.

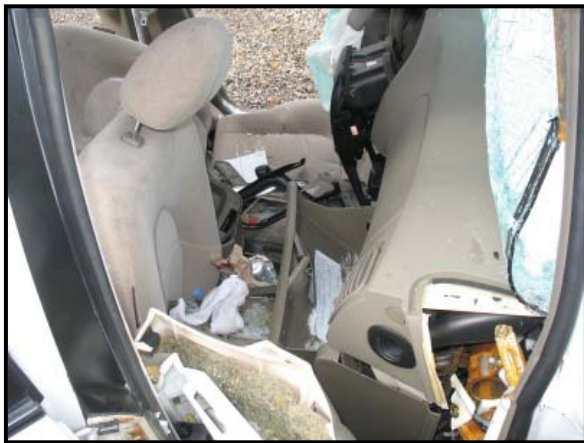
The interior of the Hyundai sustained severe right side intrusion. **Figure 14** is a right lateral view across Row 1. The right floor pan deformed and buckled vertically. The tow pan was crushed rearward to the leading edge of the front right seat cushion. The intrusion of the right instrument panel measured 51 cm (20 in). The horizontal distance from the front right seat back to the face of the instrument panel measured (17 in). The right floor pan deformed due to the extent of frontal crush. The floor pan deformation resulted in the inboard displacement of the front right seat relative to its original location. The upper aspect of the front right seat back and head restraint rotated inboard approximately 30 cm (12 in). The front right head restraint was raised at the time of the crash. The outboard aspect of the head restraint was raised 5 cm (2 in). However, the inboard aspect of the head was raised approximately 4 cm (1.5 in). The inboard aspect was lower due to a possible rebound head contact by the driver (**Figure 15**).

Figure 14: Hyundai front right interior.

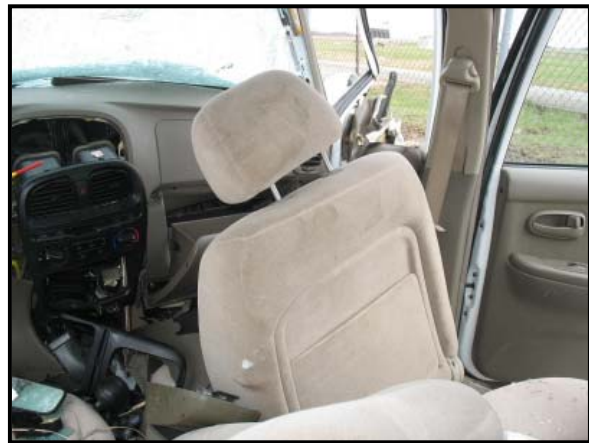
Figure 15: View of the Hyundai's front right head restraint.

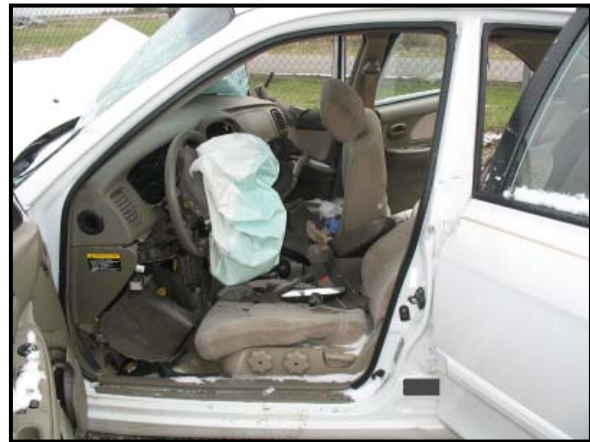
Figure 16 is a left lateral view of the driver compartment. The driver seat was adjusted to a full rear track position. The seat cushion was deformed vertically downward from driver loading. The seat back was reclined 45 degrees at the time of the SCI inspection and appeared to have been moved to that position by the first responders. The center aspect of the toe pan intruded to the brake pedal, an estimated 10 cm (4 in). There was no left instrument panel intrusion.

Figure 16: Left lateral view of the Hyundai's intrusion.
